**Flood Control Project Maintenance
Levee Inspections**

Fall 2012 Levee Maintenance Deficiency Summary Report

Sutter Maintenance Yard Maintenance Area 0007

Waterway			Bank	Unit Miles
Unit No. 01 Feather River			Right	12.07
	Spring (March - May)	Summer (June - August)	(September - November) Fall	Winter (December - February)
Unit Maintenance Rating (Fall Only)			A	
Date of Inspection	03/28/2012 - 03/28/2012		09/25/2012 - 09/25/2012	
DWR Inspector	Clay Thomas		Clay Thomas	
Accompanied By	Jason Cooper		Jason Cooper

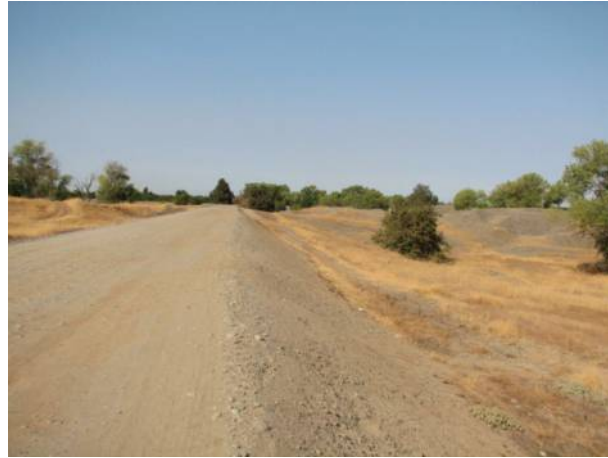
Levee Mile Report Line	4
Start Levee Mile	0.00
End Levee Mile	12.05
Location	Land Side
Category	Earthen Levee
Item	Vegetation

This photo is of the landside slope at levee mile 12.07.

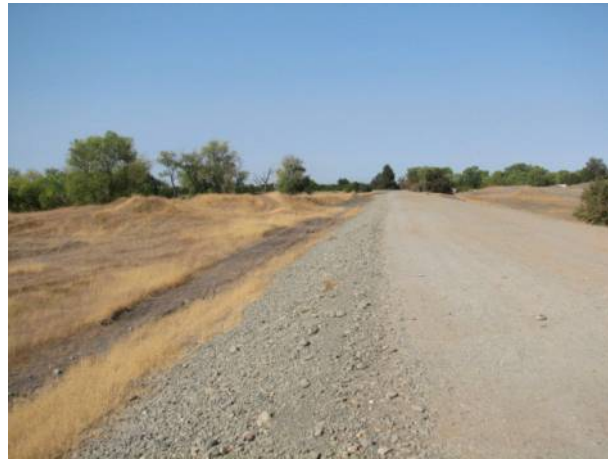
Levee Mile Report Line	5
Start Levee Mile	0.00
End Levee Mile	12.05
Location	Water Side
Category	Earthen Levee
Item	Vegetation

This photo is of the waterside slope at levee mile 12.07.

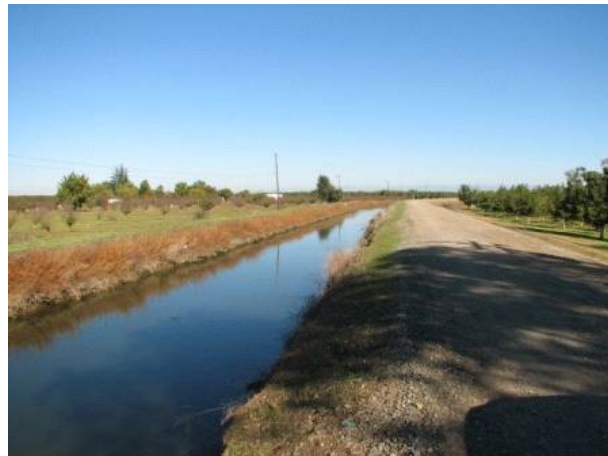
Levee Mile Report Line	6
Start Levee Mile	0.01
End Levee Mile	1.73
Location	Land Side
Category	Earthen Levee
Item	Encroachments

AG ditch landside slope and toe.

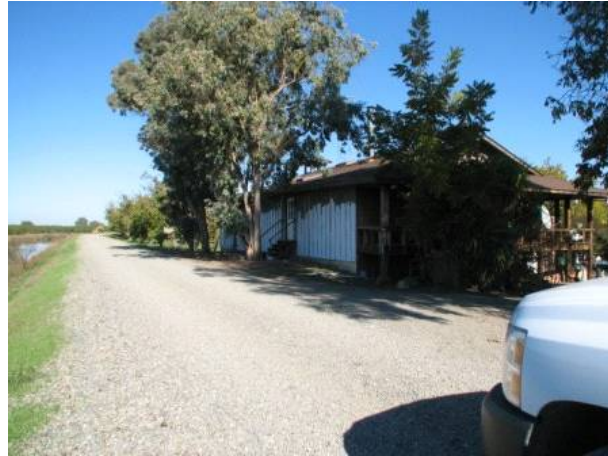
Levee Mile Report Line	7
Start Levee Mile	1.21
End Levee Mile	1.21
Location	Water Side
Category	Earthen Levee
Item	Encroachments
Levee mile 1.21. This is a photo of the building on the waterside slope.	
cathom_f_20120912_010.jpg

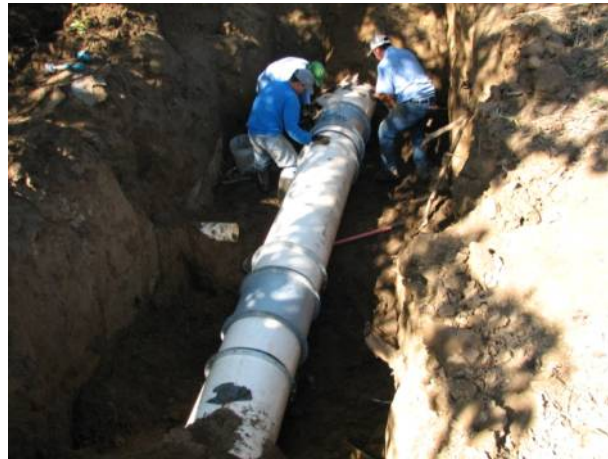
Levee Mile Report Line	9
Start Levee Mile	2.88
End Levee Mile	2.88
Location	Land Side
Category	Earthen Levee
Item	Encroachments
This photo shows a pipe approximately 24 inch in diameter at the landside toe of the levee, the pipe runs parallel with the levee, they are repairing the existing pipe.	
cathom_f_20120912_016.jpg

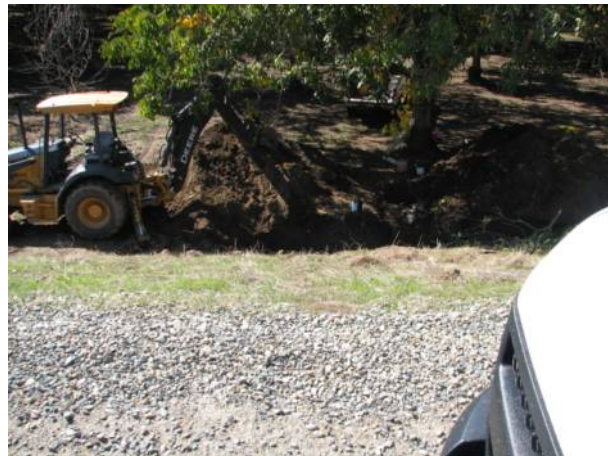
Levee Mile Report Line	9
Start Levee Mile	2.88
End Levee Mile	2.88
Location	Land Side
Category	Earthen Levee
Item	Encroachments
This is looking from the crown of the levee at the pipe repair site. Status of a permit is unknown and no verification of the repair was available.	
cathom_f_20120912_017.jpg

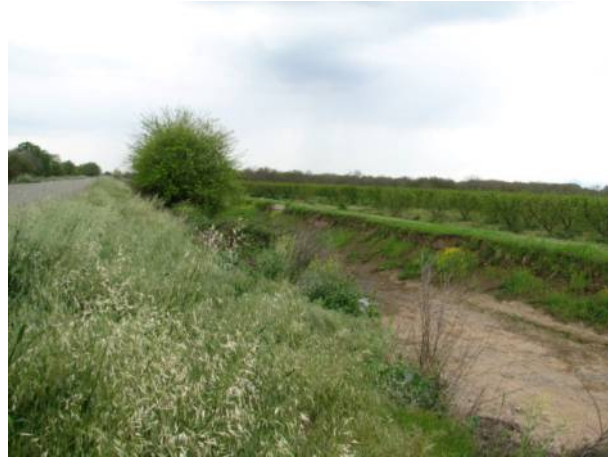
Levee Mile Report Line	10
Start Levee Mile	3.85
End Levee Mile	5.37
Location	Land Side
Category	Earthen Levee
Item	Encroachments

Levee mile 5.37. This is a photo of the Ag ditch on the landside slope and toe.

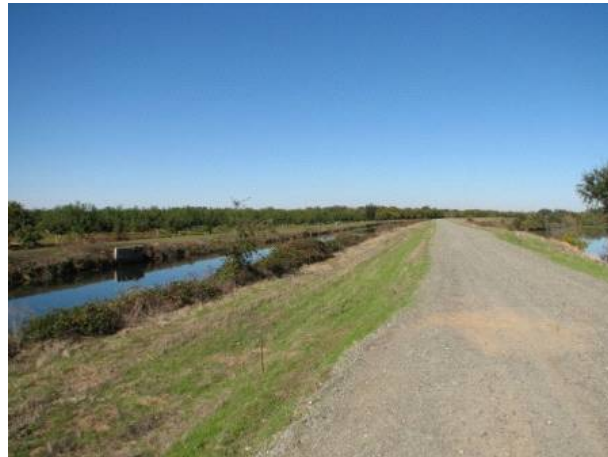
Levee Mile Report Line	10
Start Levee Mile	3.85
End Levee Mile	5.37
Location	Land Side
Category	Earthen Levee
Item	Encroachments

Ag ditch landside slope and toe.

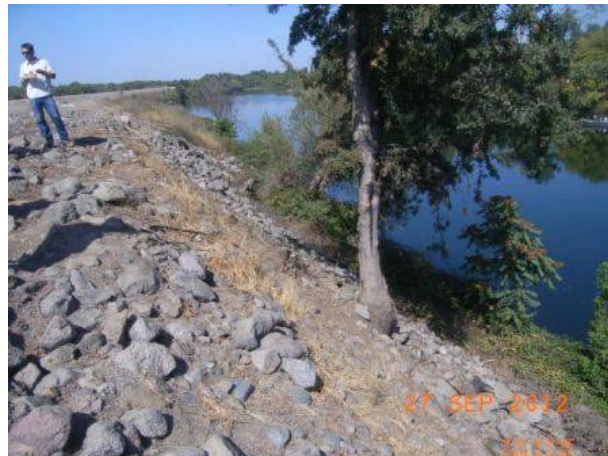
USACE 2012 Photo #1

Levee Mile Report Line	12
Start Levee Mile	4.37
End Levee Mile	4.37
Location	Water Side
Category	Supplemental
Item	USACE Erosion Survey

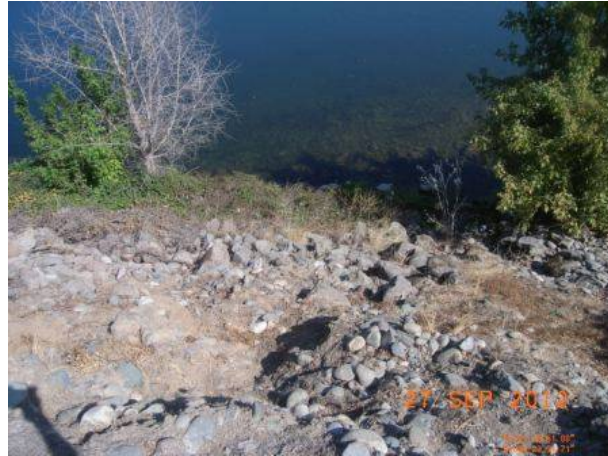
USACE 2012 Photo #2

Levee Mile Report Line	12
Start Levee Mile	4.37
End Levee Mile	4.37
Location	Water Side
Category	Supplemental
Item	USACE Erosion Survey

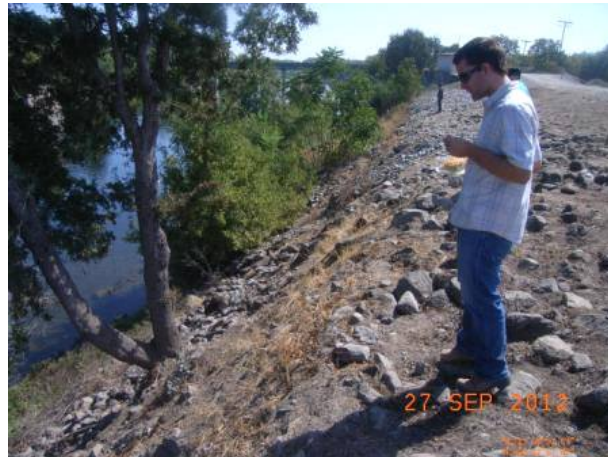
USACE 2012 Photo #3

Levee Mile Report Line	12
Start Levee Mile	4.37
End Levee Mile	4.37
Location	Water Side
Category	Supplemental
Item	USACE Erosion Survey

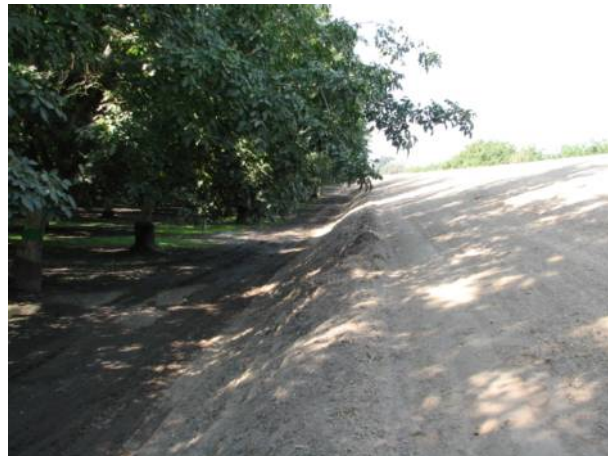
Levee Mile Report Line	14
Start Levee Mile	5.38
End Levee Mile	5.98
Location	Water Side
Category	Earthen Levee
Item	Encroachments

This photo is of the wateside toe of the levee, it does not appear to have been repaired.

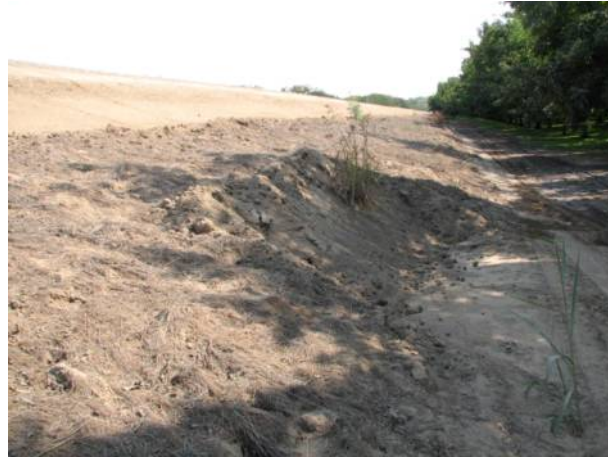
Levee Mile Report Line	14
Start Levee Mile	5.38
End Levee Mile	5.98
Location	Water Side
Category	Earthen Levee
Item	Encroachments

This photo shows where material has been remove at the waterside toe of the levee.

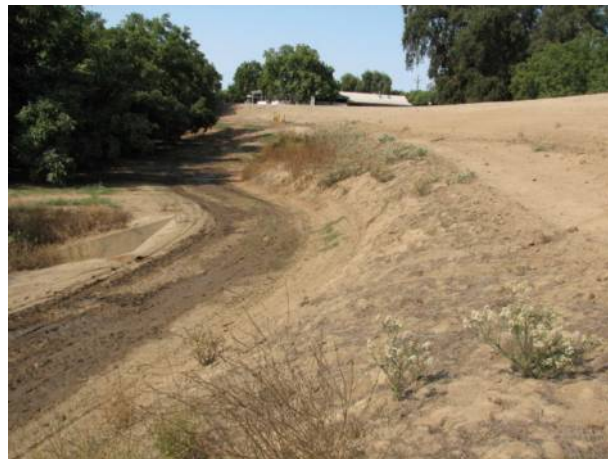
Levee Mile Report Line	14
Start Levee Mile	5.38
End Levee Mile	5.98
Location	Water Side
Category	Earthen Levee
Item	Encroachments

This photo shows vehicle traffic has cut into the toe of the levee.

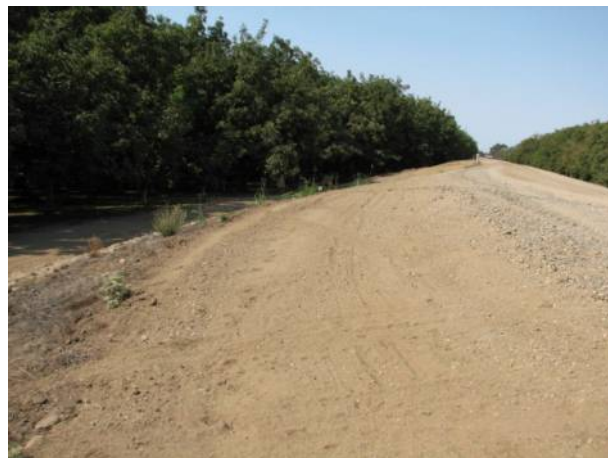
Levee Mile Report Line	14
Start Levee Mile	5.38
End Levee Mile	5.98
Location	Water Side
Category	Earthen Levee
Item	Encroachments

This photo shows the stockpile has been removed.

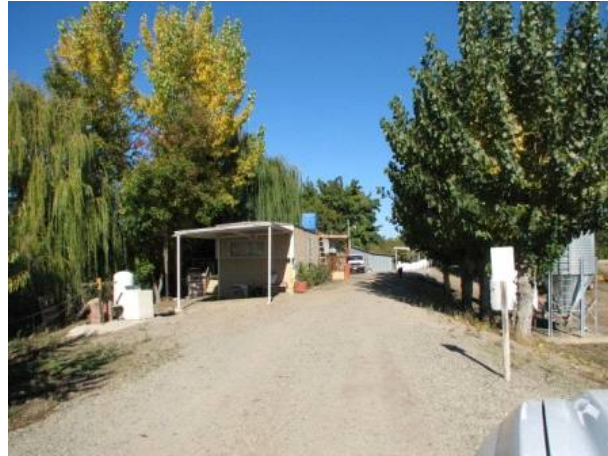
Levee Mile Report Line	16
Start Levee Mile	5.42
End Levee Mile	5.42
Location	Land Side
Category	Earthen Levee
Item	Encroachments

Levee mile 5.42. This photo shows a building on the landside crown, shoulder and slope.

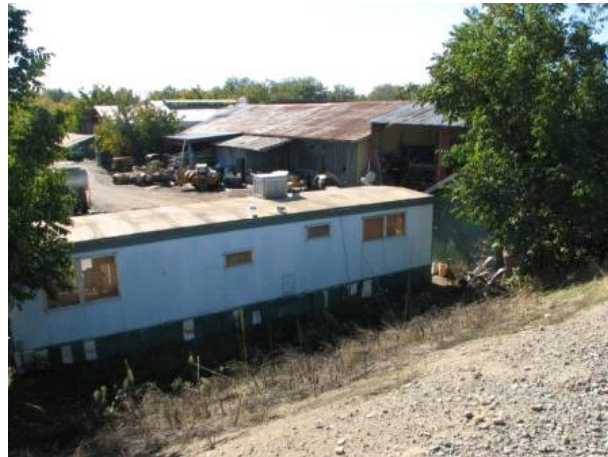
Levee Mile Report Line	19
Start Levee Mile	9.79
End Levee Mile	9.79
Location	Land Side
Category	Earthen Levee
Item	Encroachments

Levee mile 9.79. This photo shows a building at the landside toe.

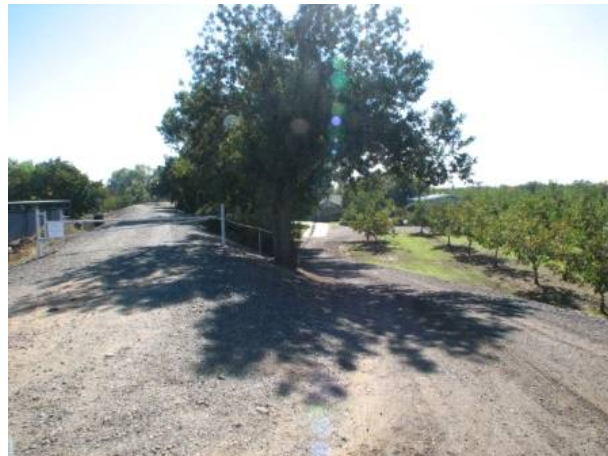
Levee Mile Report Line	21
Start Levee Mile	11.63
End Levee Mile	11.69
Location	Land Side
Category	Earthen Levee
Item	Vegetation

Landside landscaping levee mile 11.63.
